CONSTRUCTION MONITORING & EVALUATION PROGRAM

(Reconstruction of Damaged Schools in Khyber Pakhtunkhwa)

MONTHLY PROGRESS REPORT # 13
APRIL, 2014

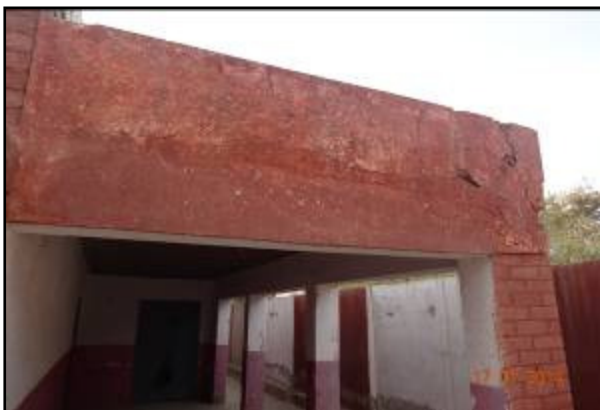
Another View of damaged school

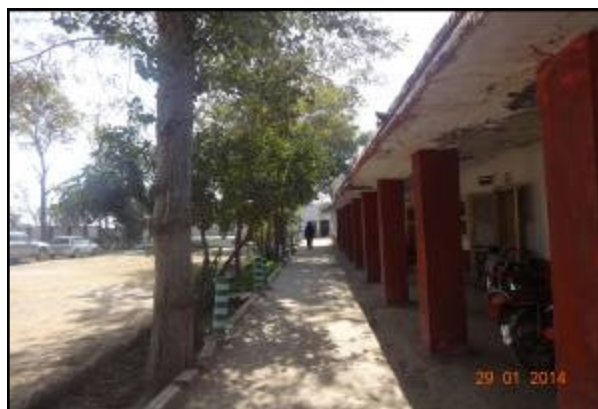
Verandah Of damaged school

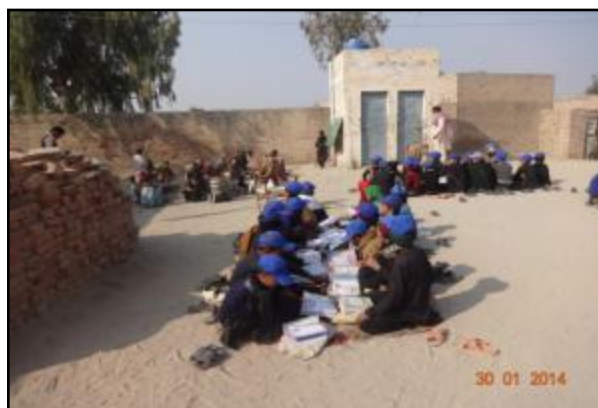
Students studying under the open sky

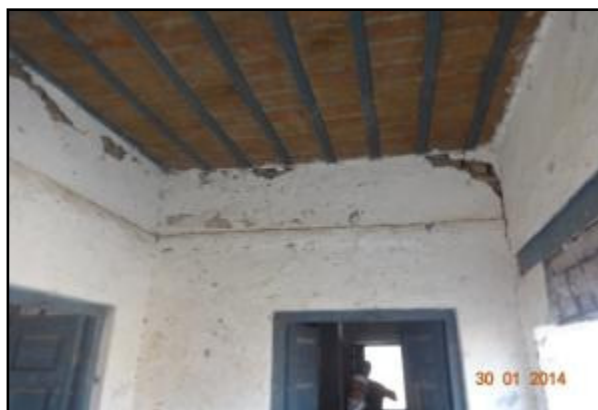
View of damaged verandah

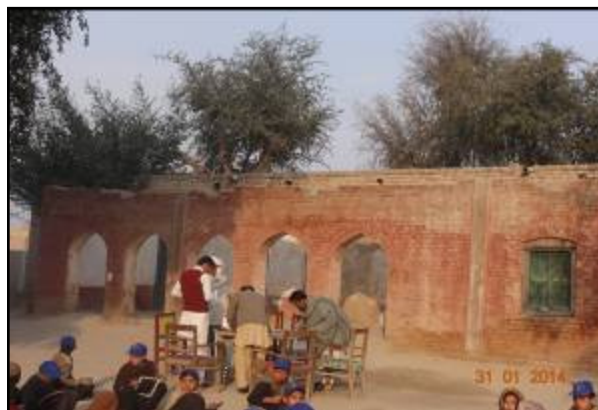
Front View of the damaged school

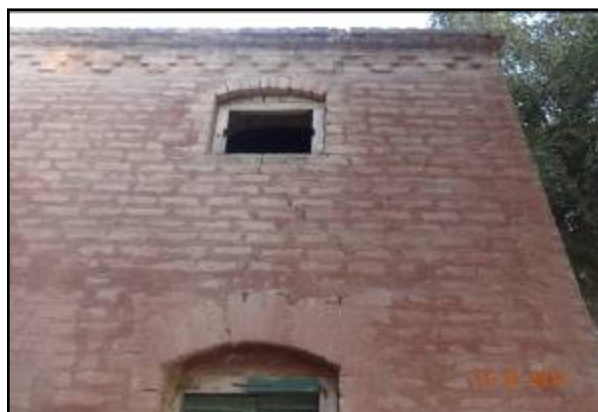
Another view of the school

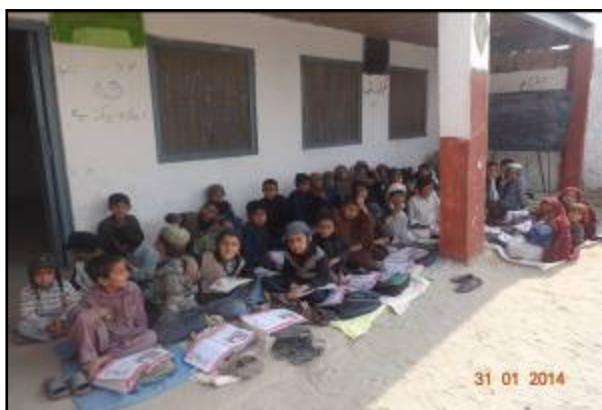
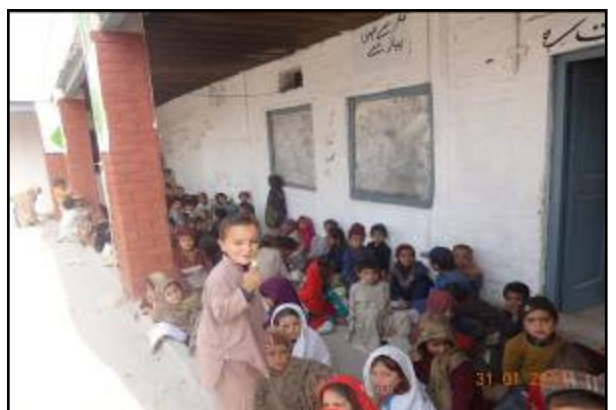
Students studying in verandah

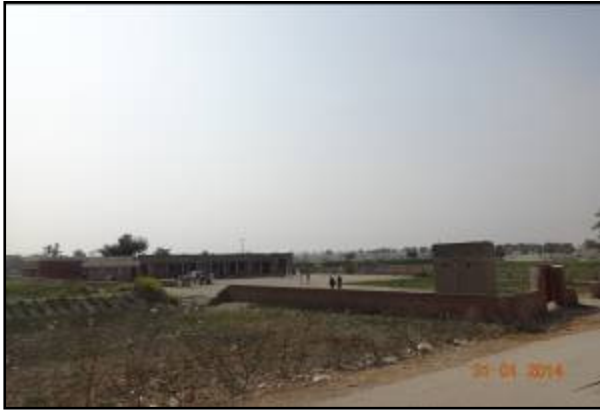
Overall View of the school

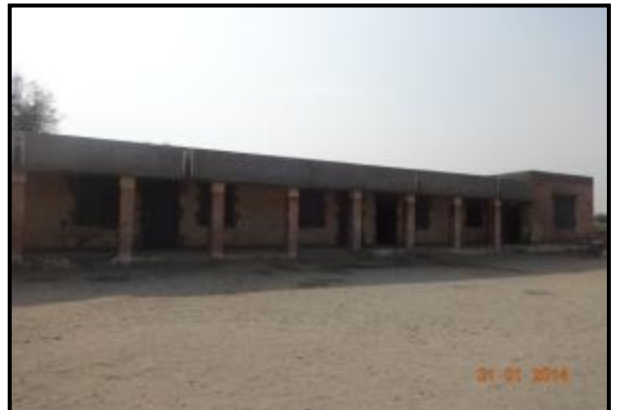
Front View of the school

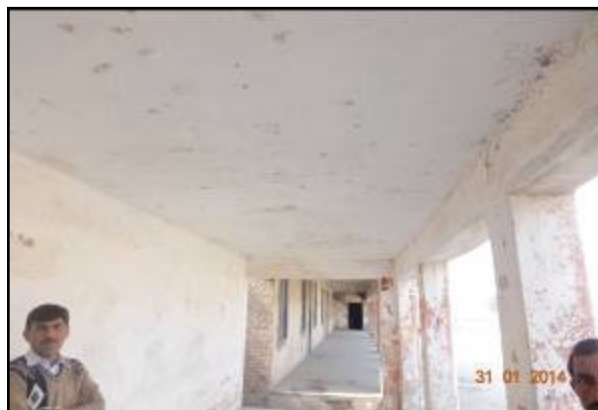
View of verandah

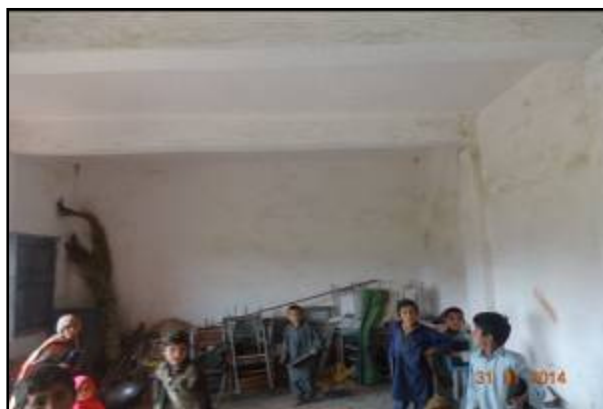
View of class room

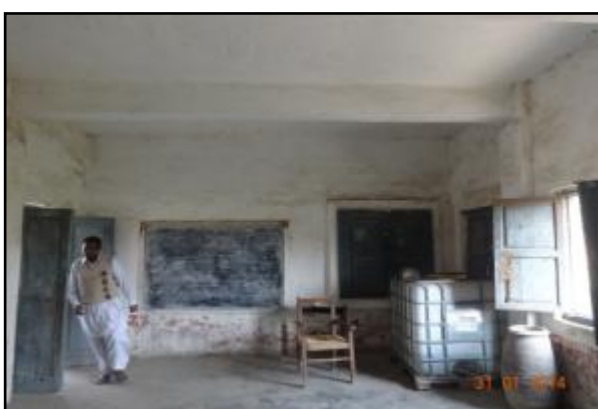
View of class room

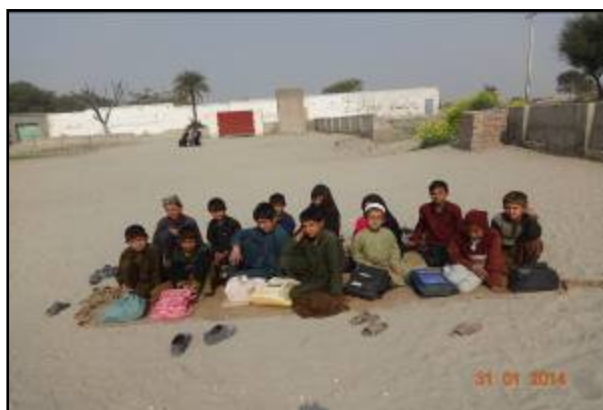
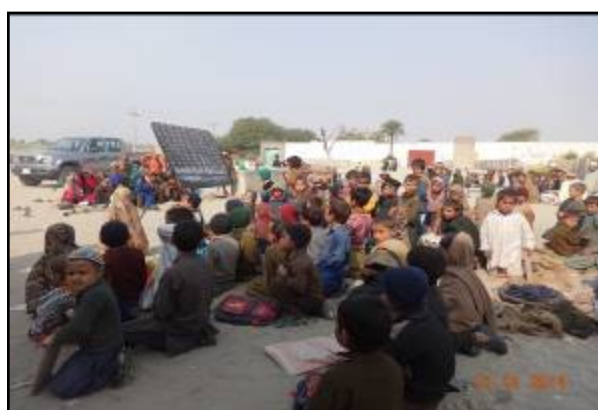
Students studying outside without any shelter

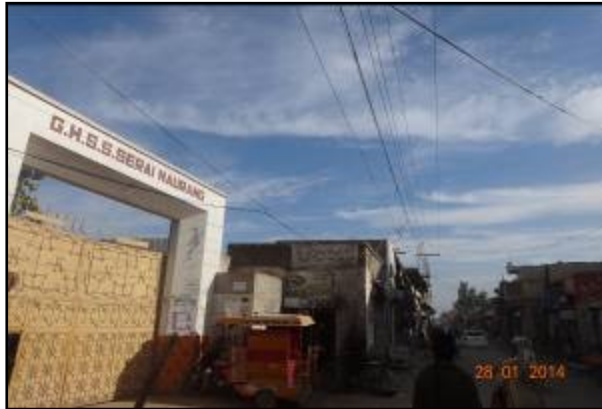
Main entrance of the school

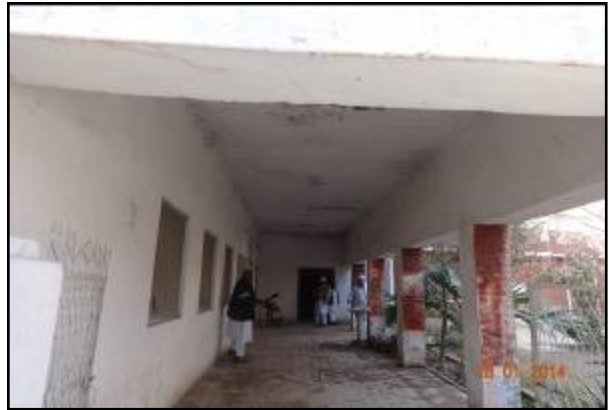
View of verandah

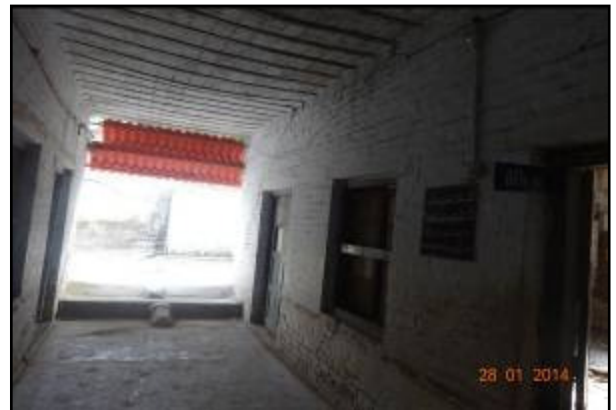
View of verandah

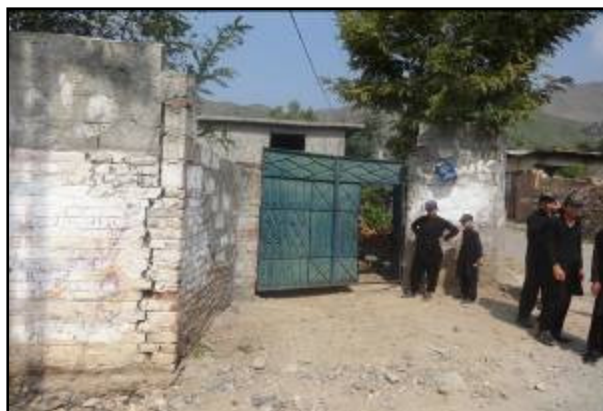
Main Entrance

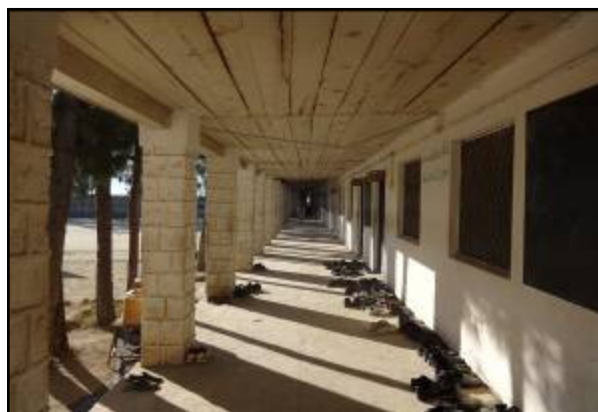
View of verandah

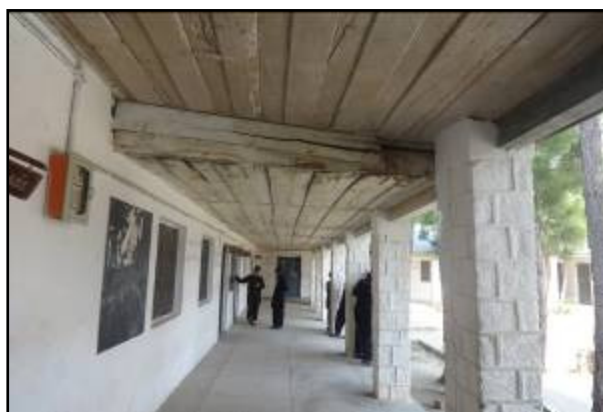
Another view of verandah

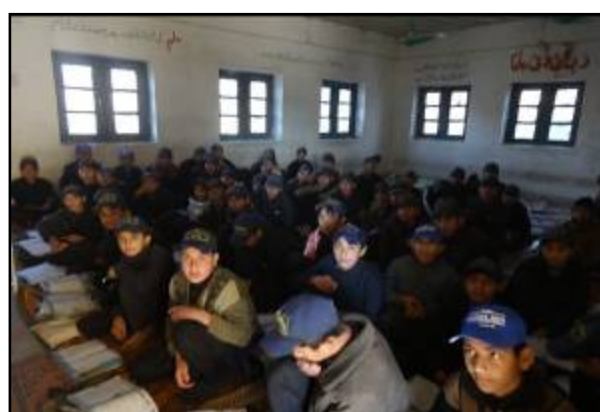
View of class room

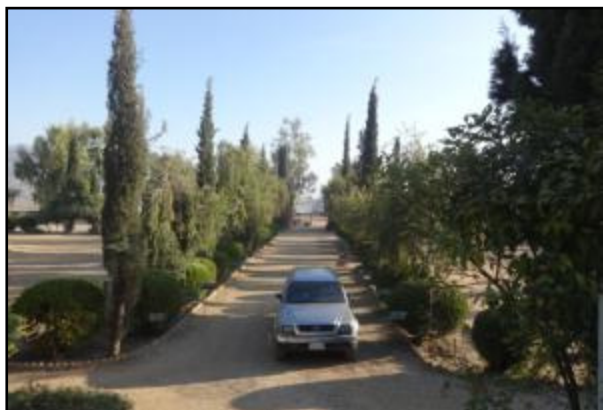
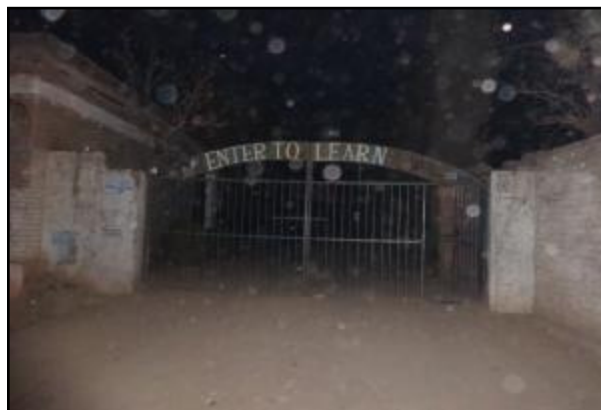
Entrance of the school

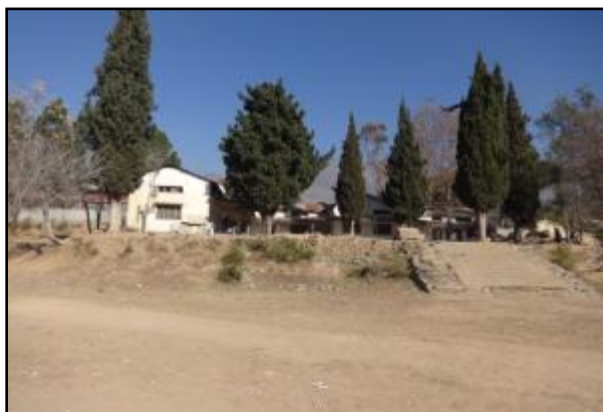
Access to the school

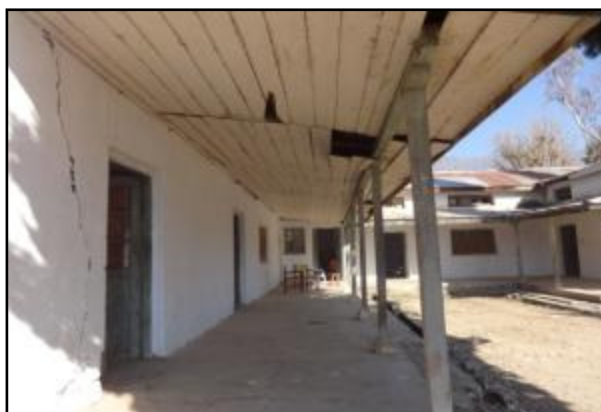
View of Verandah

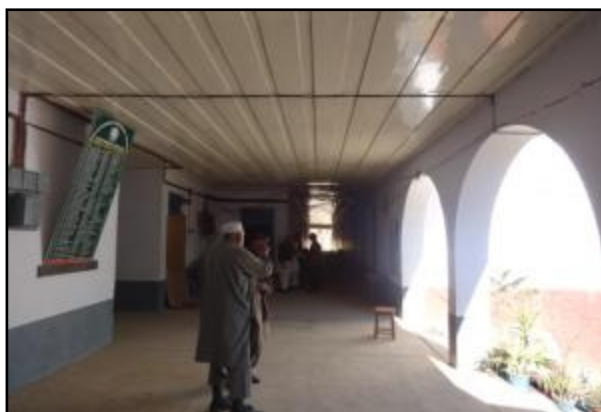
View of verandah

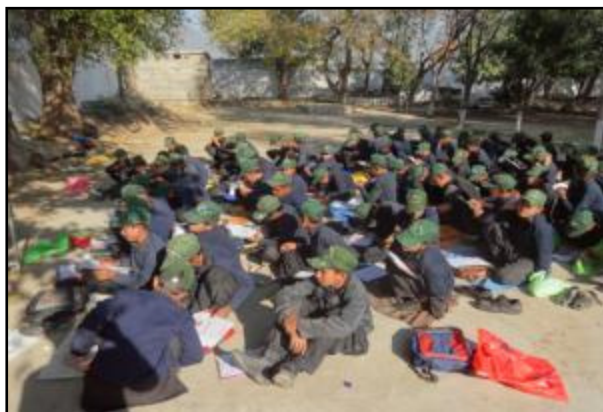
Students studying having no shelter

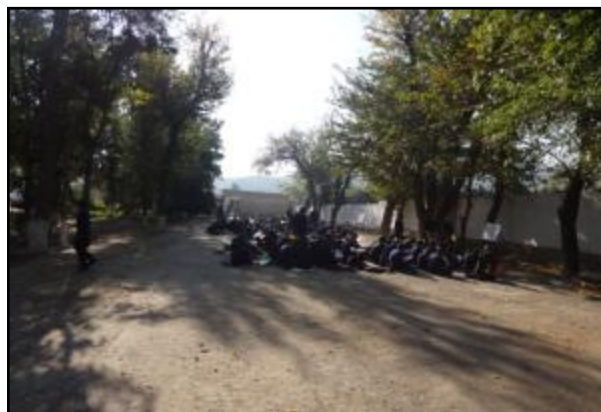
Students studying having no shelter

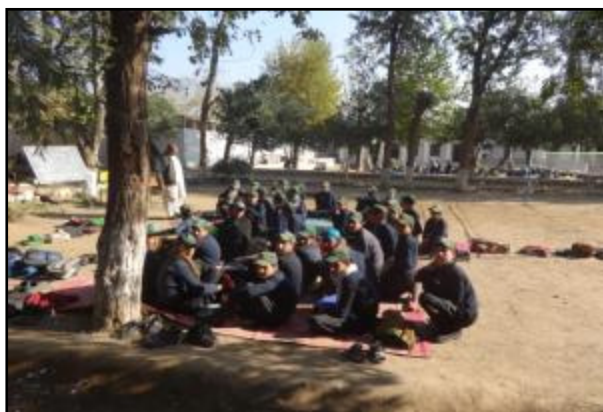
Students studying having no shelter

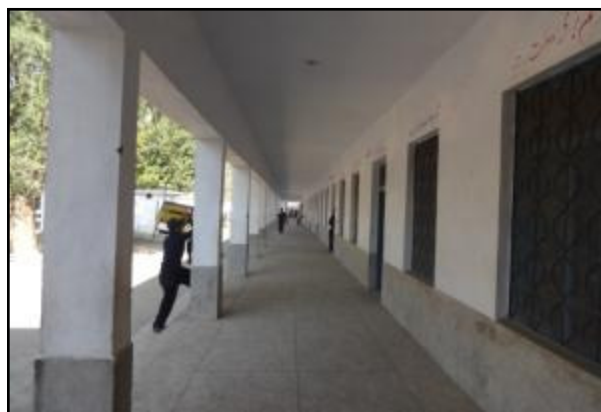
View of Verandah

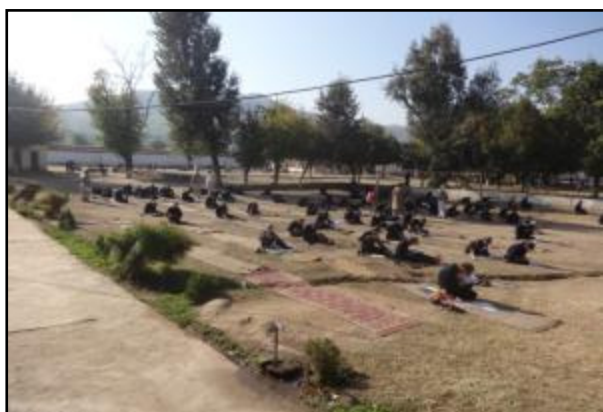
Overall View of the school

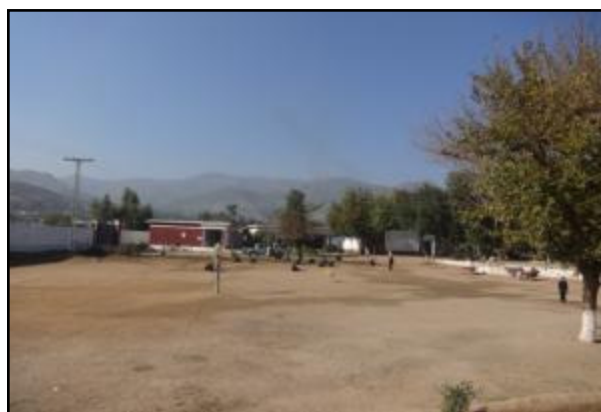
Side View of the school

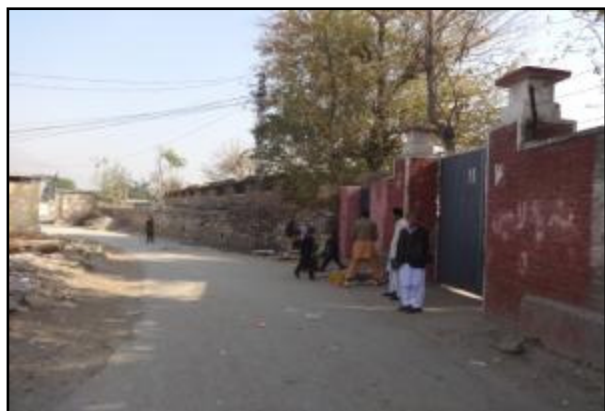
Main Entrance of the school

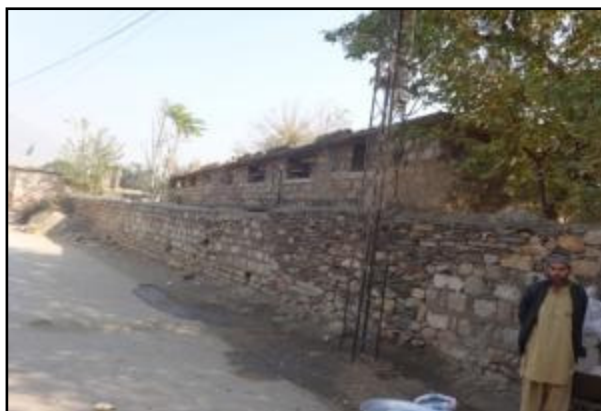
Access to the school

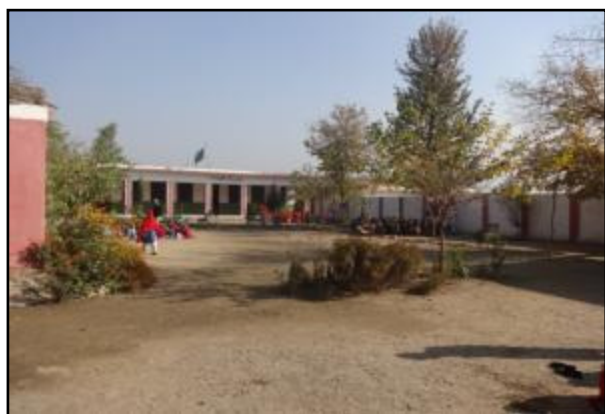
Front View of the school

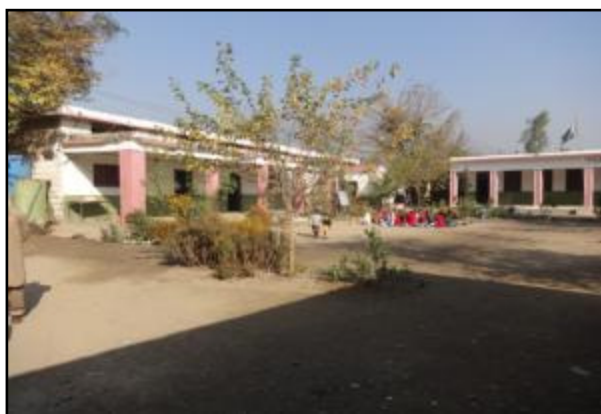
Overall View of the school

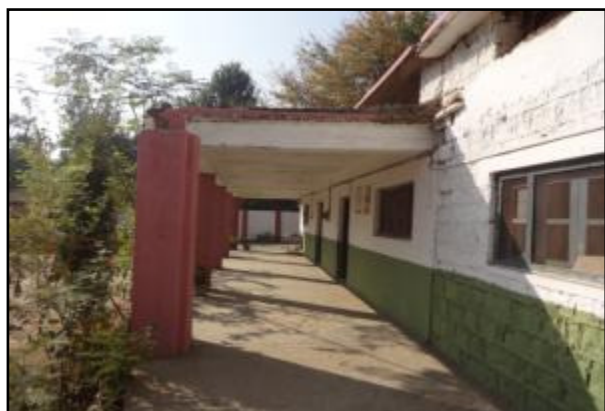
View of Verandah

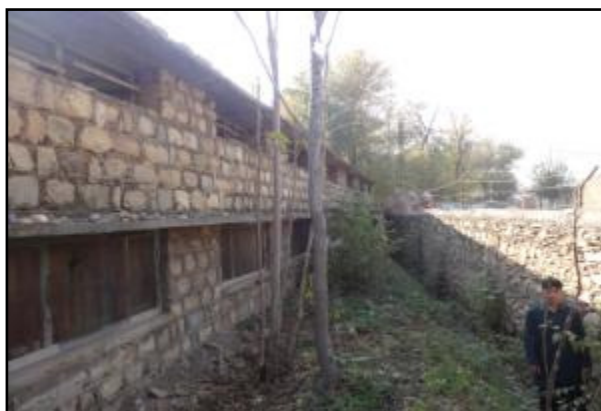
Rear View of the school
